**Flood Control Project Maintenance  
Levee Inspections**

**Fall 2012 Levee Maintenance Deficiency Summary Report**

**Reclamation District No. 2089 Stark**

**Levee Inspection Report By Mile - Fall 2012**

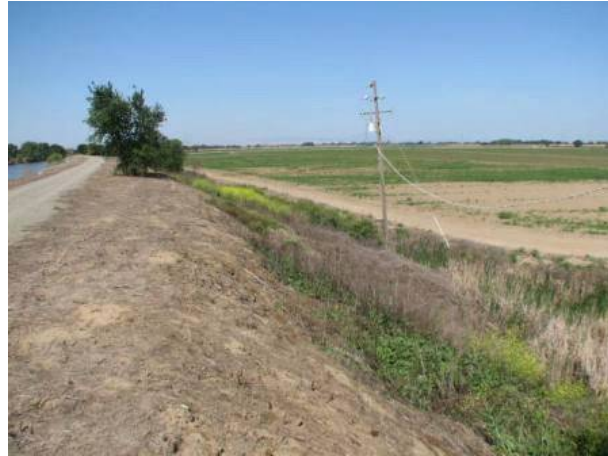
mkhashch\_f\_20120927\_225.jpg

05/24/2011 Ditch flows parallel with the utility line shown in the photo.

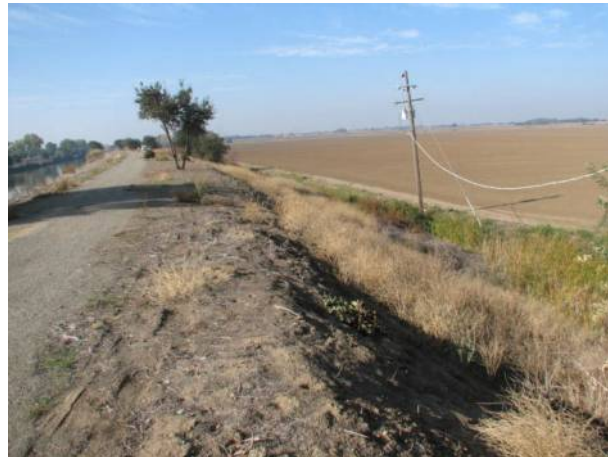
Levee Mile Report Line	5
Start Levee Mile	0.03
End Levee Mile	0.27
Location	Land Side
Category	Earthen Levee
Item	Vegetation

11/10/2011 Landside vegetation obstructs visibility of the slope and toe.

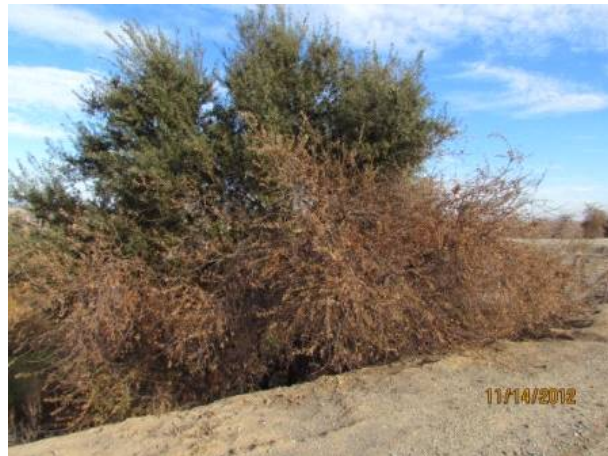
Levee Mile Report Line	6
Start Levee Mile	0.04
End Levee Mile	0.04
Location	Land Side
Category	Earthen Levee
Item	Trim / Thin Trees

View of unacceptable vegetation control on landside slope. Tree is still not trimmed up and obstructing visibility and access.

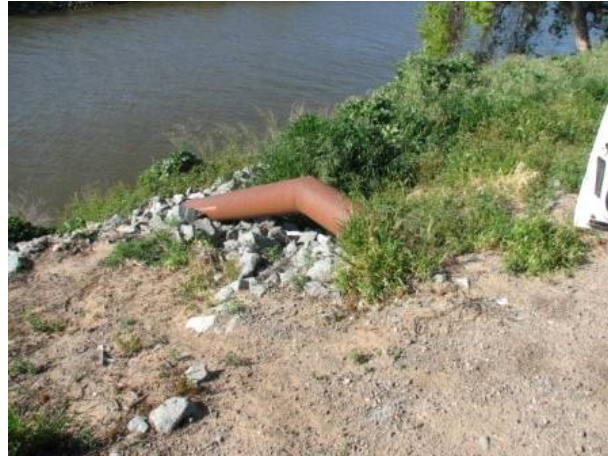
Levee Mile Report Line	7
Start Levee Mile	0.04
End Levee Mile	0.04
Location	Land Side
Category	Earthen Levee
Item	Encroachments

Waterside of drainage discharge to Old River.

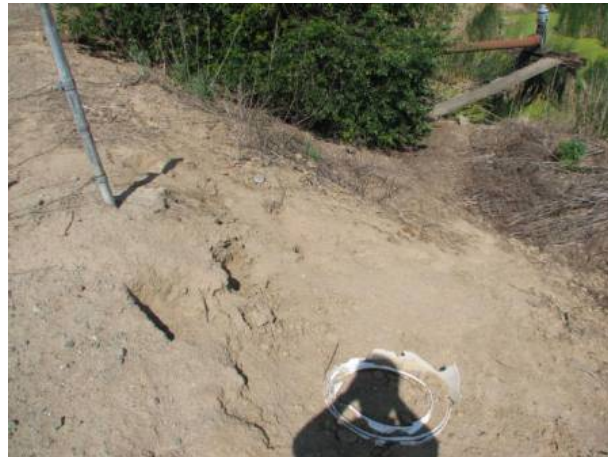
Levee Mile Report Line	8
Start Levee Mile	0.04
End Levee Mile	0.04
Location	Land Side
Category	Earthen Levee
Item	Encroachments

05/24/2011 Steps are hard to discern in the photo, the top two steps are casting the two shadows located between the post and the photographer's shadow.

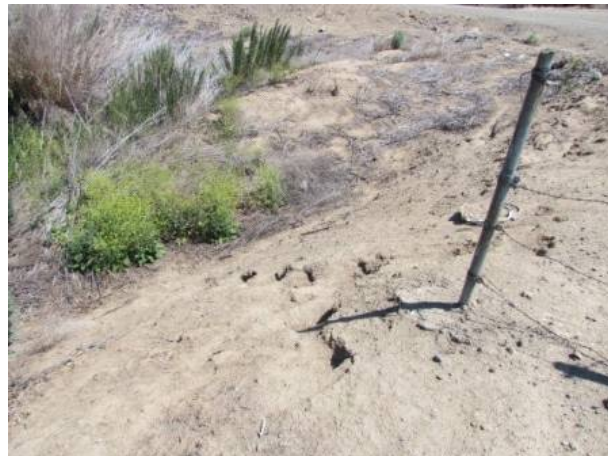
Levee Mile Report Line	8
Start Levee Mile	0.04
End Levee Mile	0.04
Location	Land Side
Category	Earthen Levee
Item	Encroachments

View of steps in the landside slope just behind the post. 05/24/2012

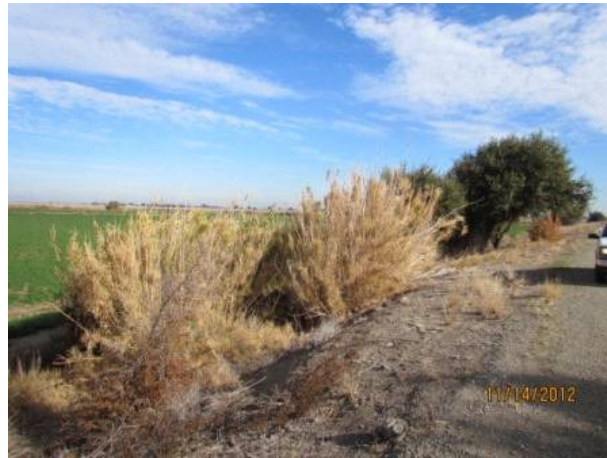
mkhashch\_f\_20121119\_776.JPG

Arundo has been sprayed. However, vegetation on the landside slope must be cleared to 15' beyond the toe.

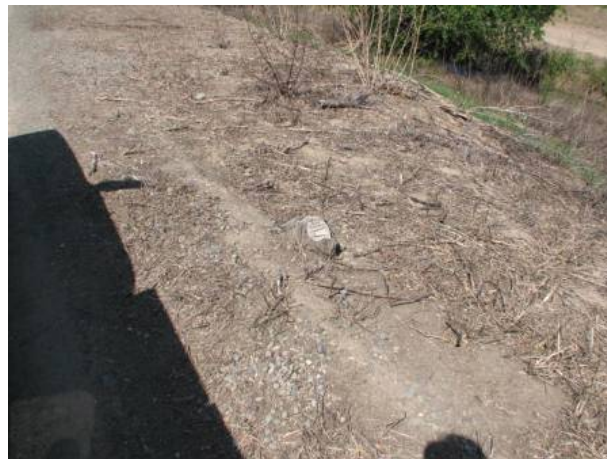
Levee Mile Report Line	15
Start Levee Mile	0.26
End Levee Mile	0.26
Location	Land Side
Category	Earthen Levee
Item	Trim / Thin Trees

05/24/2011 Stump is located in center of photo.

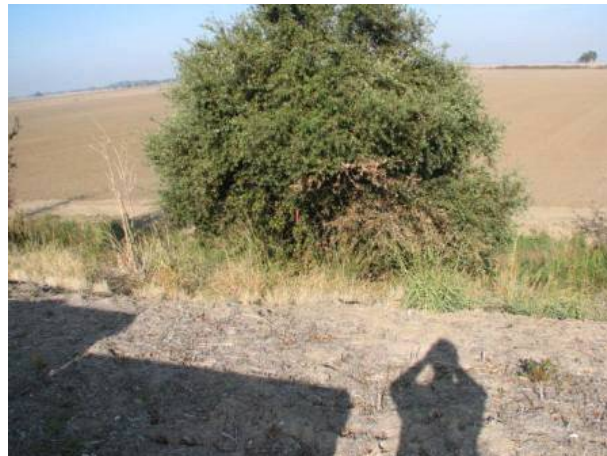
Levee Mile Report Line	16
Start Levee Mile	0.26
End Levee Mile	0.26
Location	Land Side
Category	Earthen Levee
Item	Trim / Thin Trees

11/10/2011 Tree obstructs visibility and access to slope, needs to be limbed up to 5'.

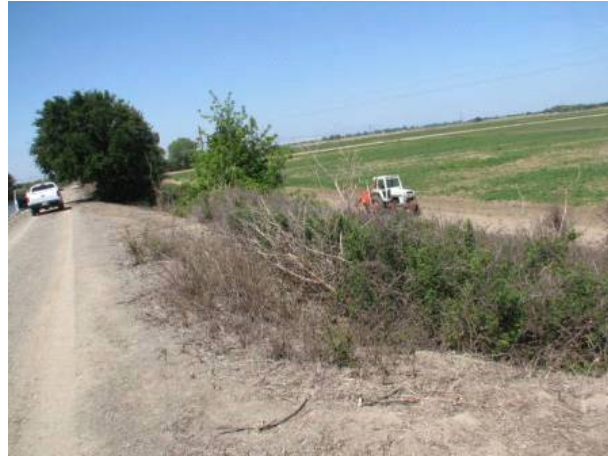
mkhashch\_f\_20120927\_228.jpg

05/24/2011 Thick brush and wild rose completely block access and visibility of landside slope and toe.

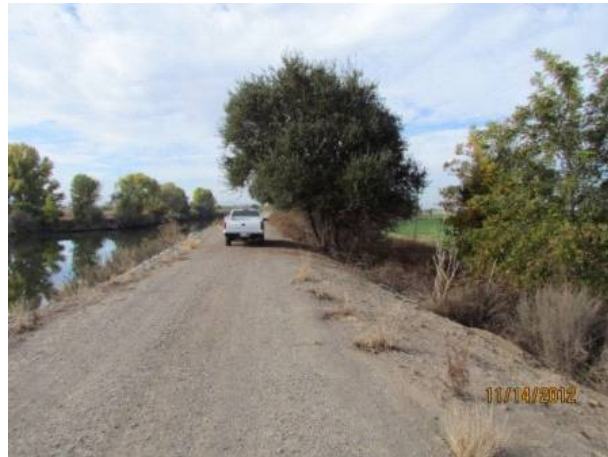
Levee Mile Report Line	18
Start Levee Mile	0.29
End Levee Mile	0.34
Location	Land Side
Category	Earthen Levee
Item	Trim / Thin Trees

Numerous trees and thick vegetation in area, trees are trimmed to 12' above roadway but not 5' on landside slope and toe to allow access and visibility.

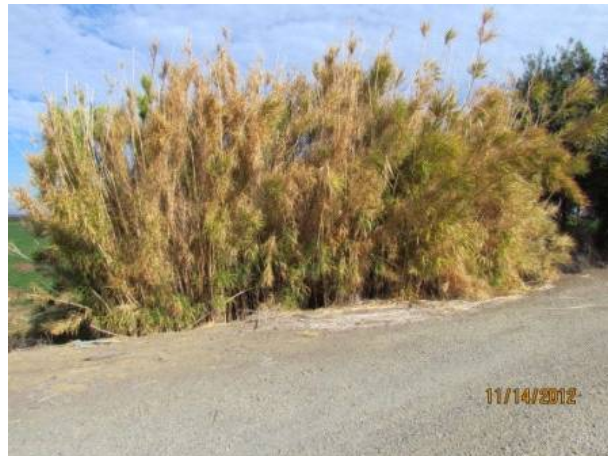
Levee Mile Report Line	20
Start Levee Mile	0.34
End Levee Mile	0.34
Location	Land Side
Category	Earthen Levee
Item	Vegetation

20	0.34	0.34	Earthen Levee	Vegetation	LS	U	V2 : Remove the wild growth other than native grasses from the levee slopes. Inspector Comments: Bamboo completely blocks access and visibility. 11/10/2011 Arundo has been trimmed back from the roadway, but still completely blocks access and visibility to the landside slope. This plant was improperly identified as bamboo in previous inspections.	37.809978 ° -121.390704 °	37.809978 ° -121.390704 °	19 Y
----	------	------	---------------	------------	----	---	---	------------------------------	------------------------------	---------

Arundo has been trimmed back from the road, but needs to be removed to so that it does not obstruct visibility and access to the landside toe.

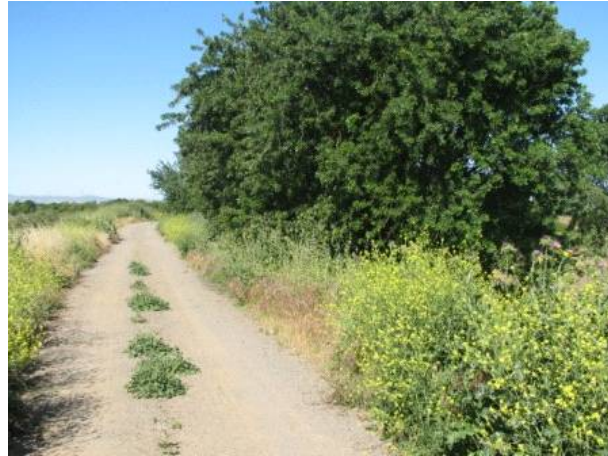
Levee Mile Report Line	21
Start Levee Mile	0.38
End Levee Mile	0.38
Location	Land Side
Category	Earthen Levee
Item	Trim / Thin Trees
Trees on levee slope obstruct access and visibility.	
mkhashch_f_20120927_284.jpg

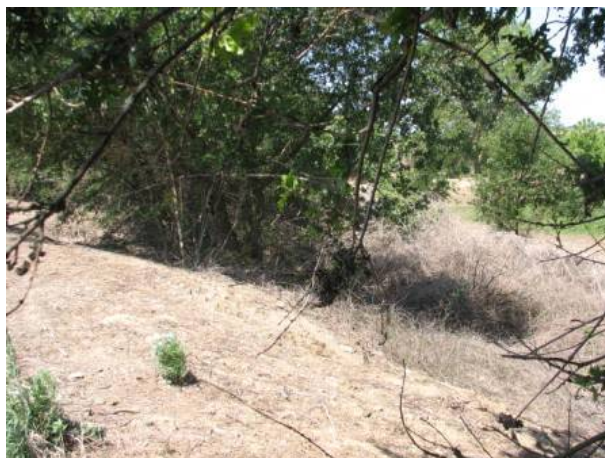
mkhashch\_f\_20120927\_244.jpg

05/24/2011 Photo shows thick dead vegetation and continuation of trees in area that are preventing access and visibility of landside slope and toe.

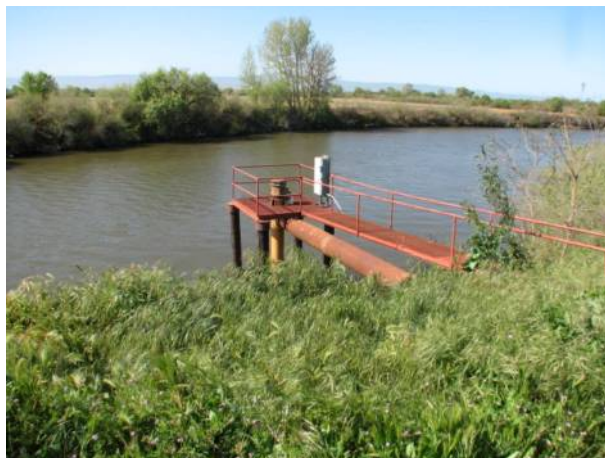
Levee Mile Report Line	26
Start Levee Mile	0.47
End Levee Mile	0.47
Location	Water Side
Category	Earthen Levee
Item	Encroachments

Irrigation intake pump and pipe at LM 0.46.

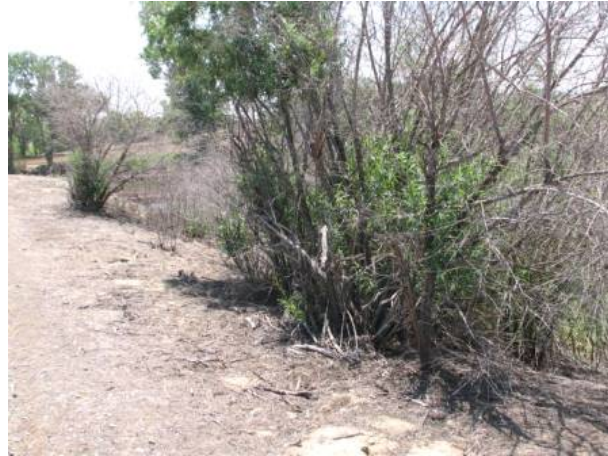
Levee Mile Report Line	27
Start Levee Mile	0.50
End Levee Mile	0.50
Location	Water Side
Category	Earthen Levee
Item	Trim / Thin Trees
05/24/2011 Trees on waterside need to be thinned to allow access and visibility of top 20' of waterside slope.	
mkhashch_f_20120927_245.jpg

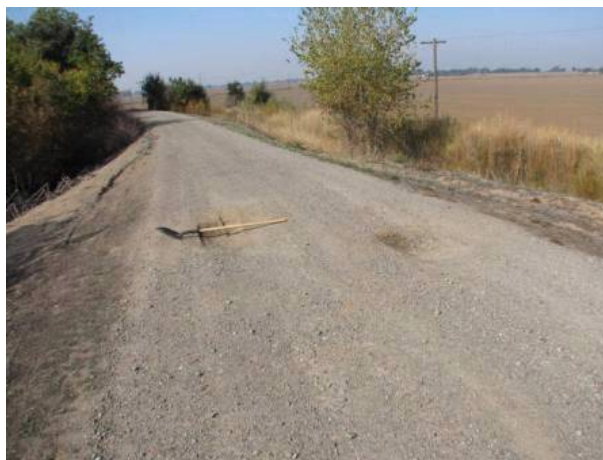
Levee Mile Report Line	29
Start Levee Mile	0.56
End Levee Mile	0.56
Location	Crown
Category	Earthen Levee
Item	Crown Surface / Depressions / Rutting
11/10/2011 Depressions in crown.	
mkhashch_f_20120927_230.jpg

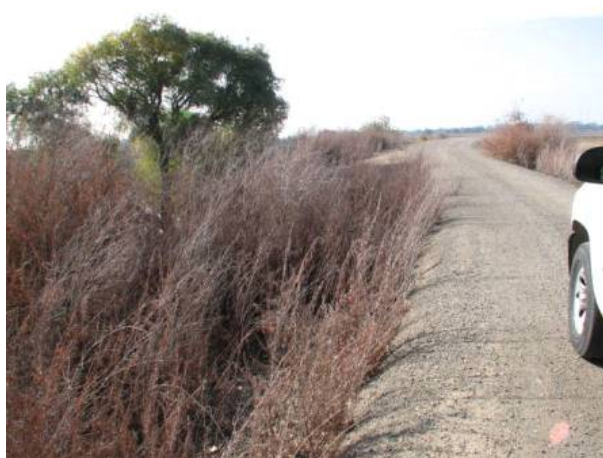
Levee Mile Report Line	31
Start Levee Mile	0.64
End Levee Mile	1.53
Location	Water Side
Category	Earthen Levee
Item	Vegetation
11/10/2011 Vegetation needs to be cleared on the upper 20' of the waterside slope.	
mkhashch_f_20120927_235.jpg

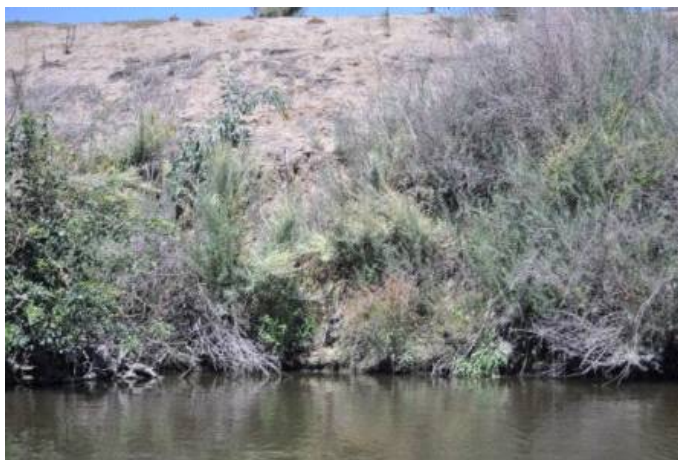
SJR2012\_RD2089U01RM29.61\_1.jpg

Front view of the site. The scarp is visible on the slope.

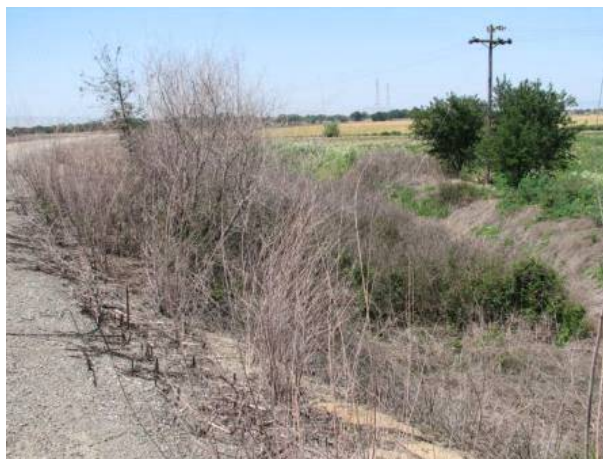
Levee Mile Report Line	34
Start Levee Mile	0.67
End Levee Mile	0.68
Location	Land Side
Category	Earthen Levee
Item	Vegetation

05/24/2011 Vegetation is mostly dead but needs to be removed to allow access and visibility of slope and toe.

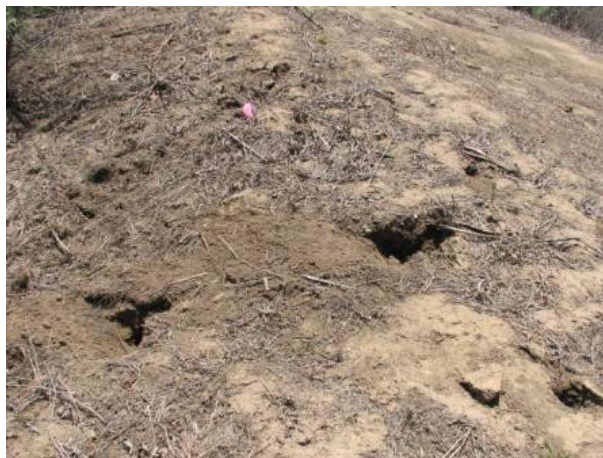
Levee Mile Report Line	35
Start Levee Mile	0.67
End Levee Mile	0.67
Location	Water Side
Category	Earthen Levee
Item	Animal Control

05/24/2011 Two active burrows shown in photo.

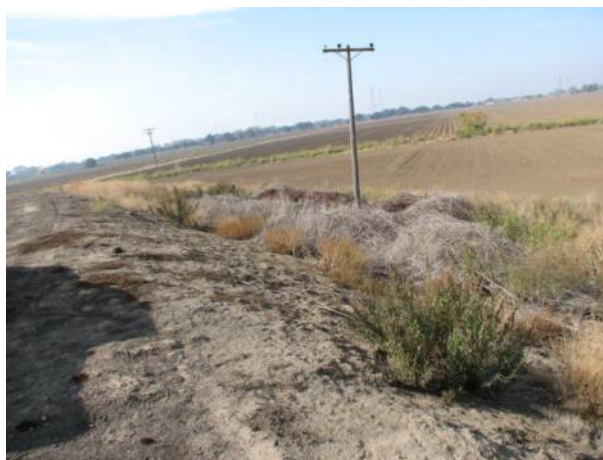
mkhashch\_f\_20120927\_238.jpg

11/10/2011 Vegetation obstructs visibility of slope and toe.

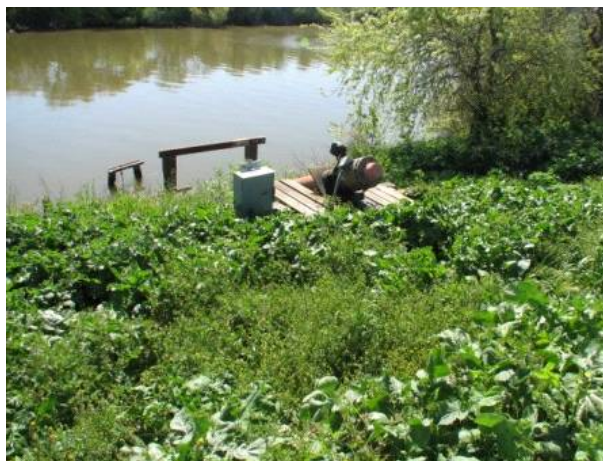
Levee Mile Report Line	37
Start Levee Mile	0.82
End Levee Mile	0.82
Location	Water Side
Category	Earthen Levee
Item	Encroachments

Irrigation intake pump and pipe on levee slope.

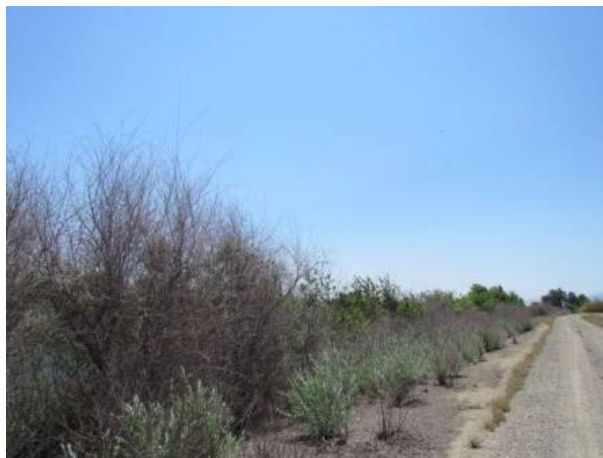
Levee Mile Report Line	38
Start Levee Mile	0.85
End Levee Mile	1.07
Location	Water Side
Category	Earthen Levee
Item	Vegetation

View of tall weeds and brush obstructing visibility on waterside slope. 05/24/2012

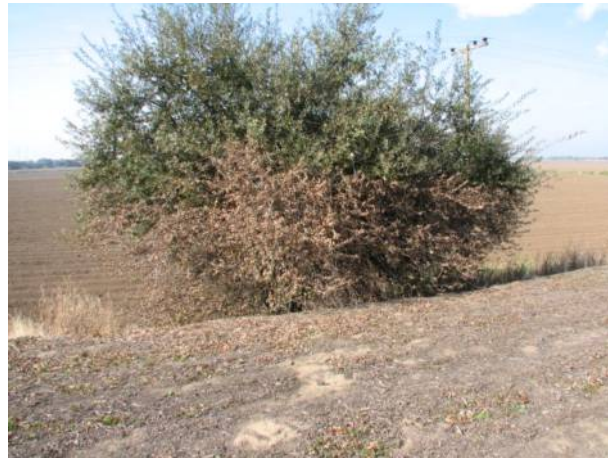
mkhashch\_f\_20120927\_240.jpg

11/10/2011 Tree appears to have been sprayed, needs to be limbed up 5' to allow for visibility of slope and toe.

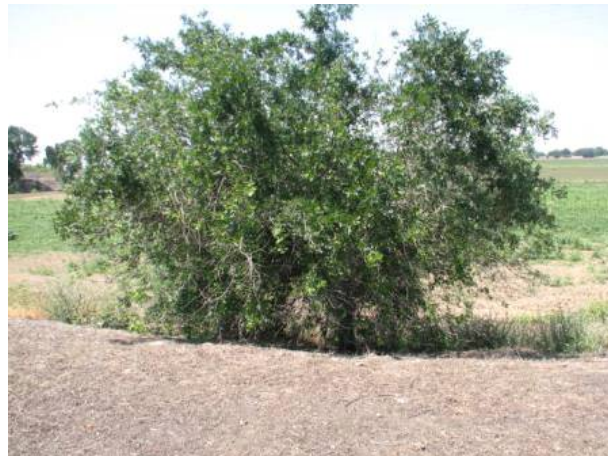
Levee Mile Report Line	41
Start Levee Mile	0.97
End Levee Mile	0.97
Location	Land Side
Category	Earthen Levee
Item	Trim / Thin Trees

05/24/2011 Tree needs to be trimmed up 5'.

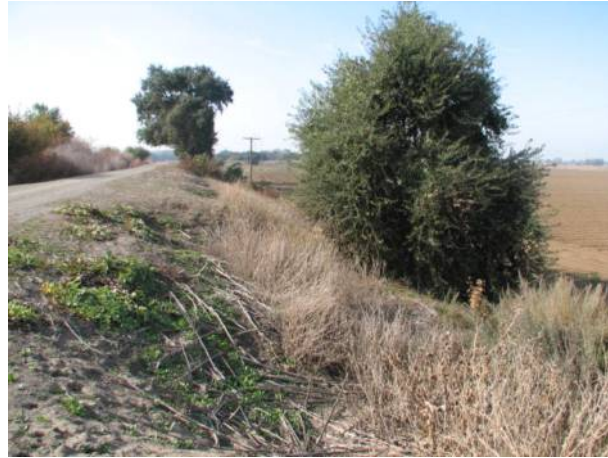
Levee Mile Report Line	42
Start Levee Mile	0.98
End Levee Mile	0.98
Location	Land Side
Category	Earthen Levee
Item	Vegetation
11/10/2011 Vegetation obstructs visibility of the slope and toe.	
mkhashch_f_20120927_255.jpg

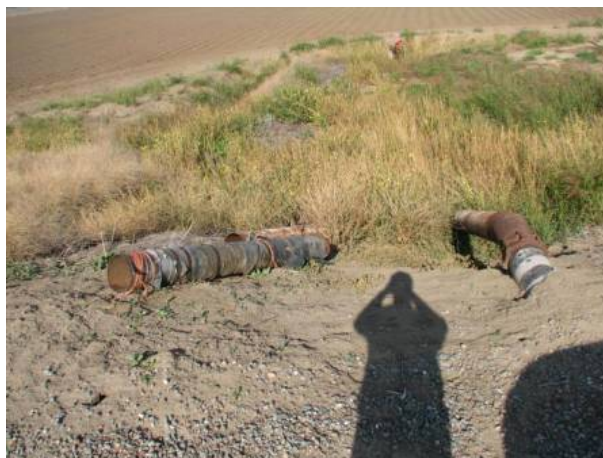
mkhashch\_f\_20120927\_256.jpg

11/10/2011 Section of ductilie iron pipe that sppears to be left from a pipe repair. Needs to be removed.

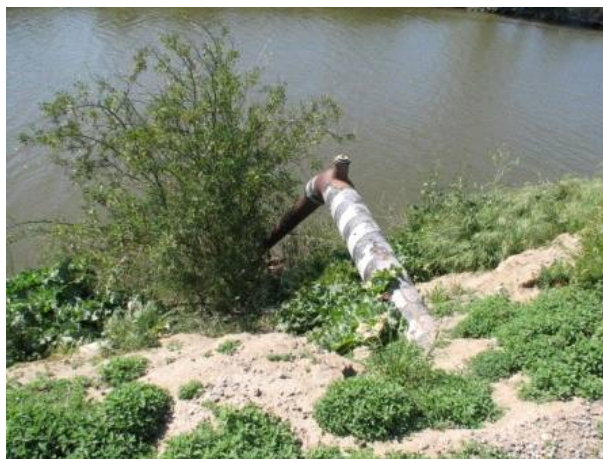
Levee Mile Report Line	48
Start Levee Mile	1.16
End Levee Mile	1.16
Location	Water Side
Category	Earthen Levee
Item	Encroachments

Drainage discharge into Old River.

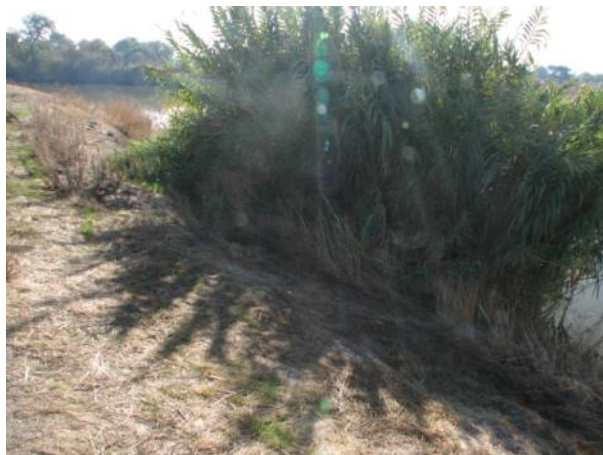
Levee Mile Report Line	49
Start Levee Mile	1.22
End Levee Mile	1.22
Location	Water Side
Category	Earthen Levee
Item	Vegetation

Bamboo on waterside levee slope obstructs access and visibility.

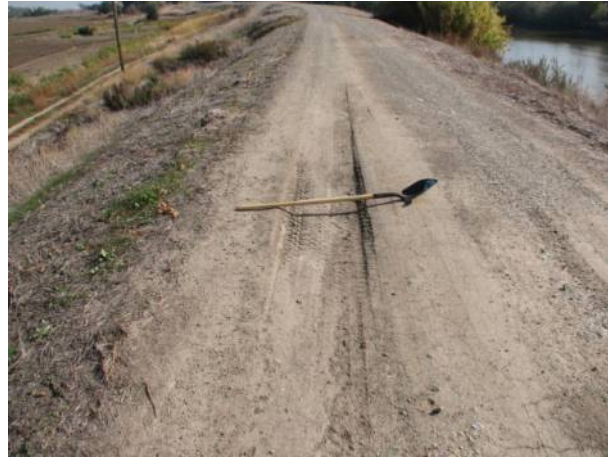
mkhashch\_f\_20120927\_257.jpg

11/10/2011 Depression in roadway.

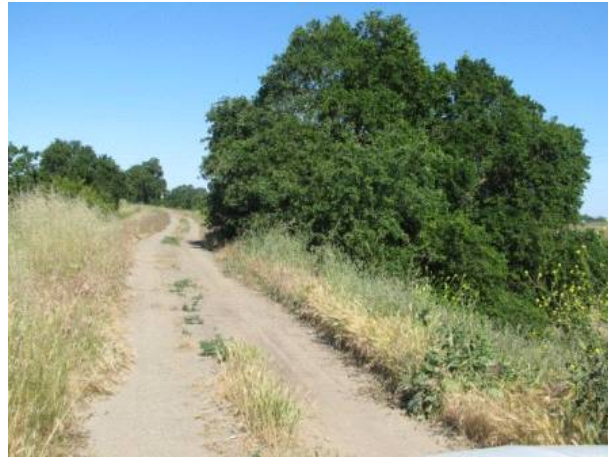
Levee Mile Report Line	51
Start Levee Mile	1.26
End Levee Mile	1.26
Location	Land Side
Category	Earthen Levee
Item	Trim / Thin Trees

Trees on levee slope obstruct access and visibility.

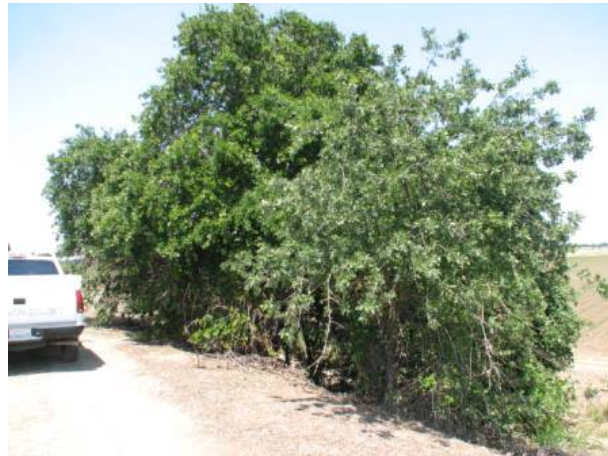
Levee Mile Report Line	51
Start Levee Mile	1.26
End Levee Mile	1.26
Location	Land Side
Category	Earthen Levee
Item	Trim / Thin Trees

05/24/2011 Trees have been trimmed since Fall 2010 inspection, however they still need to be trimmed up 5' to allow visibility of slope and access in a flood fight.

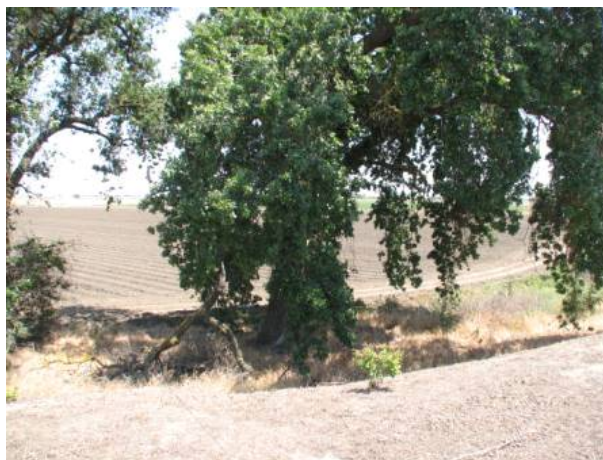
mkhashch\_f\_20120927\_290.jpg

05/24/2011 Issue noted in Fall 2010 inspection. Downed limb is visible beneath the overhanging limbs.

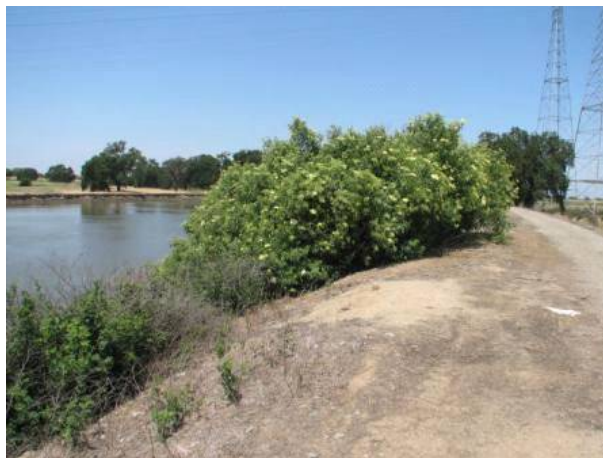
mkhashch\_f\_20120927\_292.jpg

05/24/2011 Updated photo of issue noted in Fall 2010 inspection.

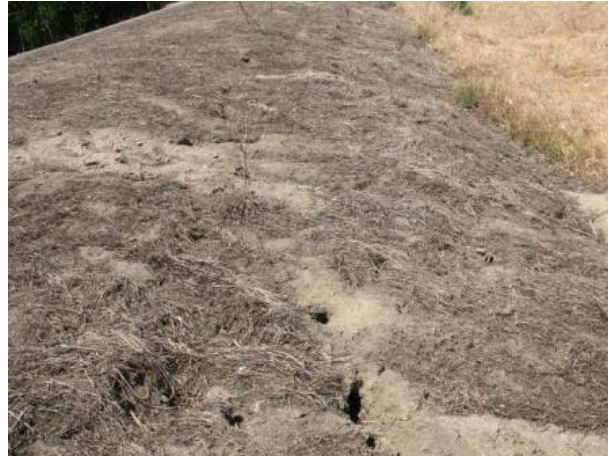
Levee Mile Report Line	4
Start Levee Mile	0.28
End Levee Mile	0.28
Location	Land Side
Category	Earthen Levee
Item	Animal Control
05/24/2011 Active burrows, ground squirrel sighted in area.	
mkhashch_f_20120927_302.jpg

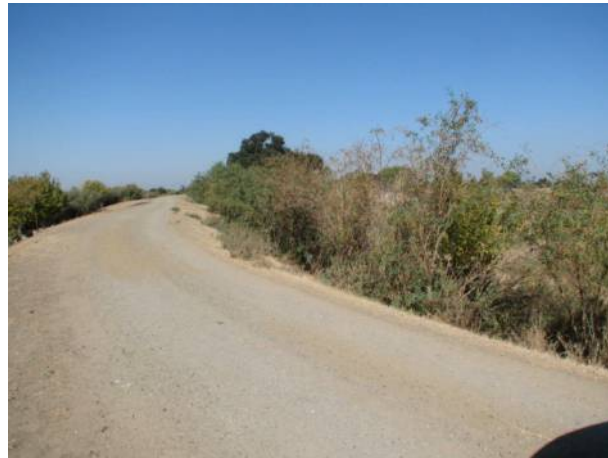
Levee Mile Report Line	7
Start Levee Mile	0.40
End Levee Mile	0.66
Location	Land Side
Category	Earthen Levee
Item	Vegetation
Fall 2009 photo: brush on landside toe limits visibility and accessibility.	
mkhashch_f_20120927_293.jpg

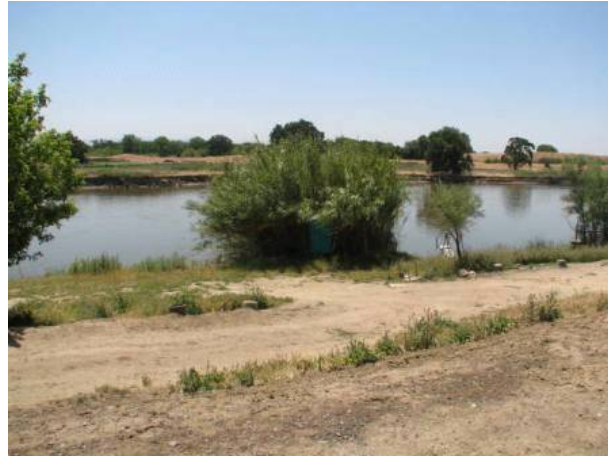
mkhashch\_f\_20120927\_304.jpg

05/24/2011 Portable toilet is in the shadows in the center of the photo at the water's edge.

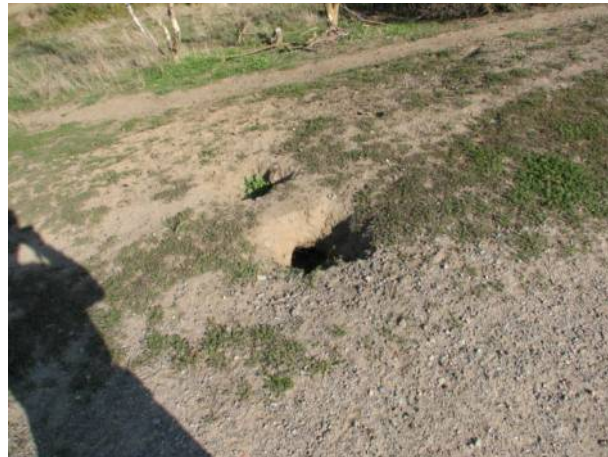
mkhashch\_f\_20120927\_297.jpg

Levee Mile Report Line	10
Start Levee Mile	0.49
End Levee Mile	0.49
Location	Crown
Category	Earthen Levee
Item	Animal Control

11/10/2011 Two large burrows on crown, need to be filled.

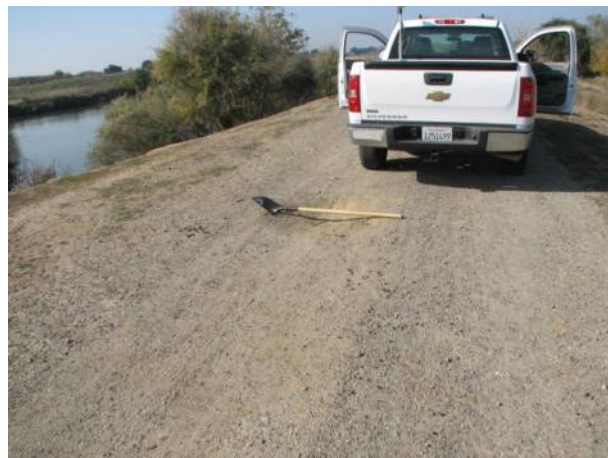
mkhashch\_f\_20120927\_295.jpg

Levee Mile Report Line	11
Start Levee Mile	0.49
End Levee Mile	0.49
Location	Crown
Category	Earthen Levee
Item	Crown Surface / Depressions / Rutting

11/10/2011 Depression in crown needs to be filled.

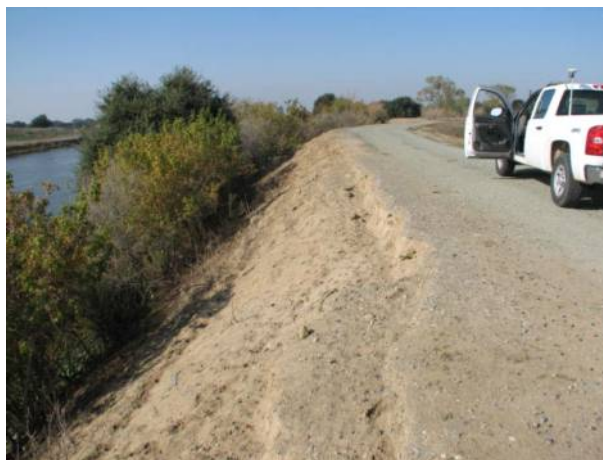
mkhashch\_f\_20120927\_298.jpg

11/10/2011 Approximately 1' scarp has been created by livestock travel.

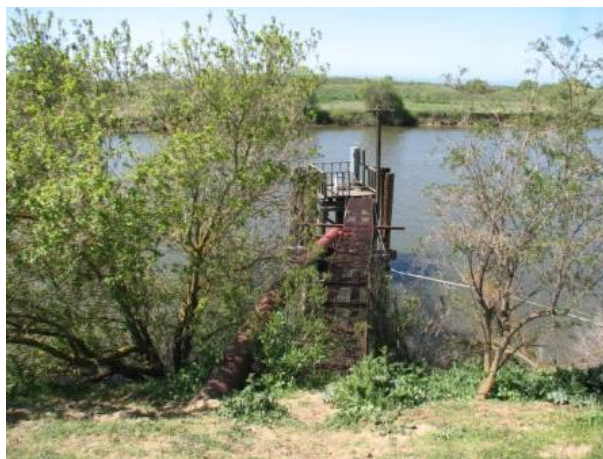
mkhashch\_f\_20120927\_296.jpg

Levee Mile Report Line	13
Start Levee Mile	0.56
End Levee Mile	0.56
Location	Water Side
Category	Earthen Levee
Item	Encroachments

Irrigation intake pump and pipe at waterside slope.

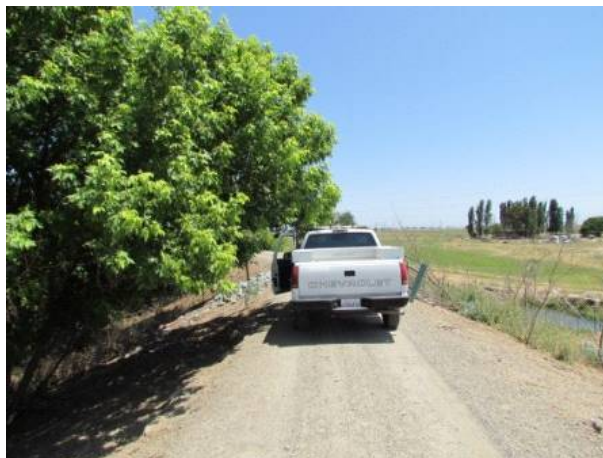
mkhashch\_f\_20120927\_314.jpg

Levee Mile Report Line	14
Start Levee Mile	0.70
End Levee Mile	0.70
Location	Water Side
Category	Earthen Levee
Item	Trim / Thin Trees

View of low hanging branches over waterside slope and crown. 05/24/2012

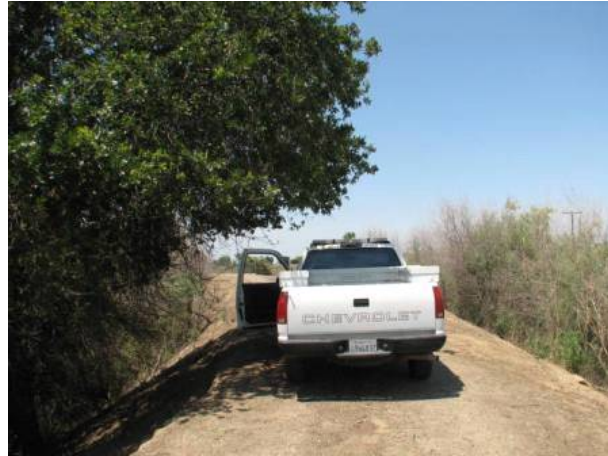
mkhashch\_f\_20120927\_308.jpg

05/24/2011 Trees need to be trimmed up 12' over road.

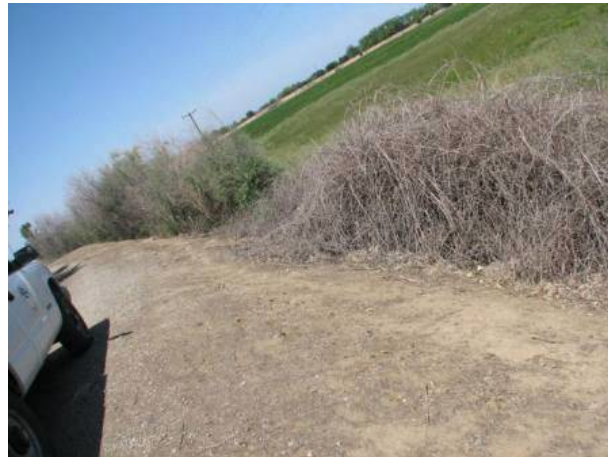
mkhashch\_f\_20120927\_307.jpg

Levee Mile Report Line	16
Start Levee Mile	0.82
End Levee Mile	0.86
Location	Land Side
Category	Earthen Levee
Item	Vegetation

05/24/2011 Extremely thick dead brush prevents access and visibility.

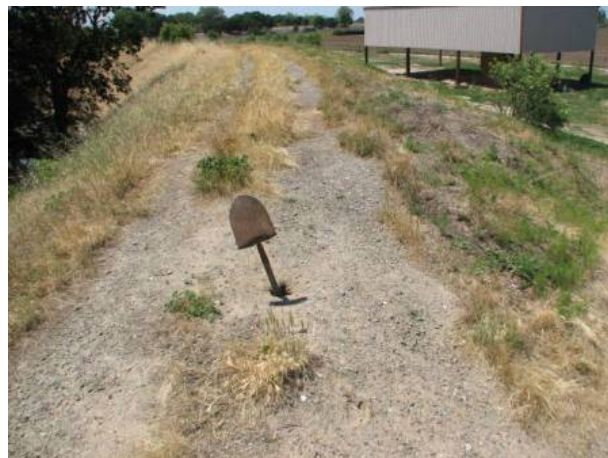
mkhashch\_f\_20120927\_309.jpg

Levee Mile Report Line	21
Start Levee Mile	0.87
End Levee Mile	0.92
Location	Land Side
Category	Earthen Levee
Item	Animal Control

05/24/2011 Deep vertical burrow in levee crown.

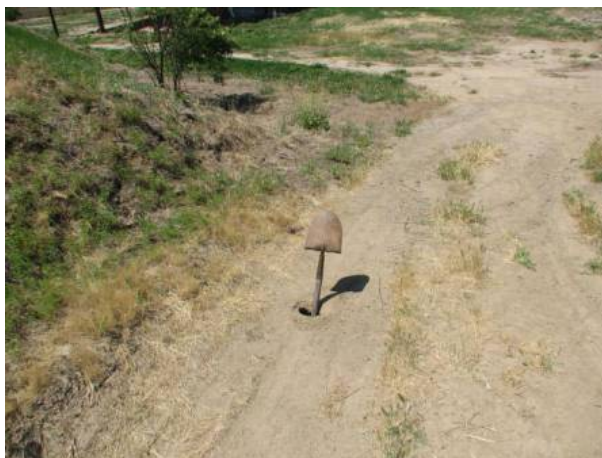
mkhashch\_f\_20120927\_310.jpg

05/24/2011 Deep vertical burrow in ramp on land side of levee.

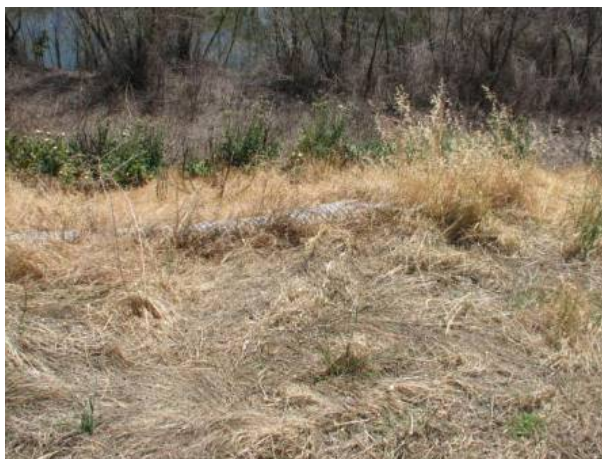
mkhashch\_f\_20120927\_311.jpg

Levee Mile Report Line	22
Start Levee Mile	0.95
End Levee Mile	0.95
Location	Water Side
Category	Earthen Levee
Item	Encroachments

05/24/2011 Old CMP left on waterside levee slope, needs to be removed.

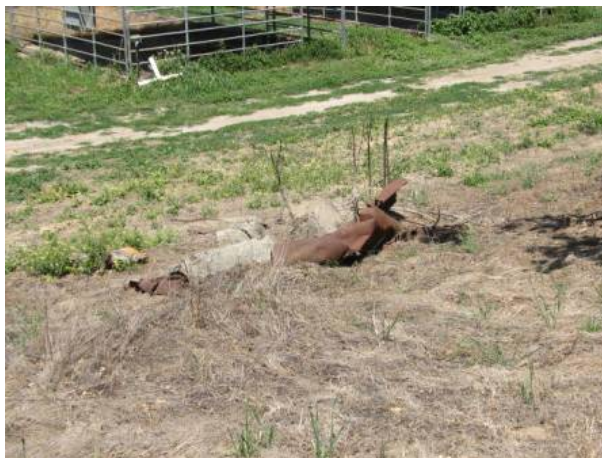
mkhashch\_f\_20120927\_305.jpg

Levee Mile Report Line	23
Start Levee Mile	0.99
End Levee Mile	0.99
Location	Land Side
Category	Earthen Levee
Item	Encroachments

05/24/2011 Concrete and metal debris at landside toe needs to be removed.

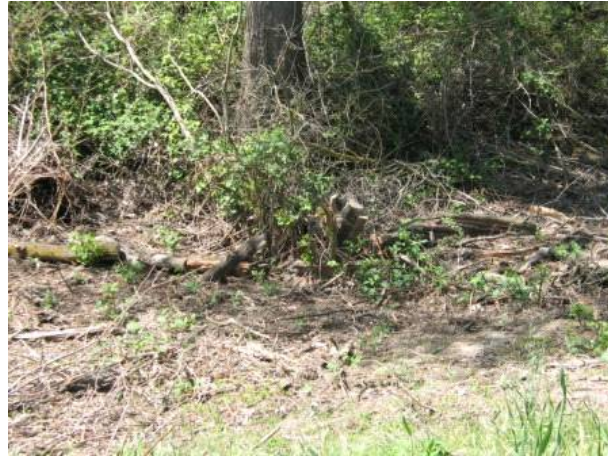
mkhashch\_f\_20120927\_306.jpg

Tree stump >2" left after vegetation and tree removal.

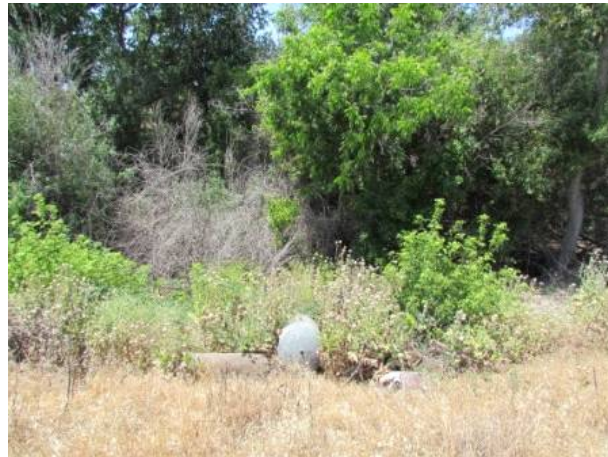
mkhashch\_f\_20120927\_299.jpg

Levee Mile Report Line	26
Start Levee Mile	1.10
End Levee Mile	1.10
Location	Water Side
Category	Earthen Levee
Item	Encroachments

View of water tanks disposed on waterside slope.

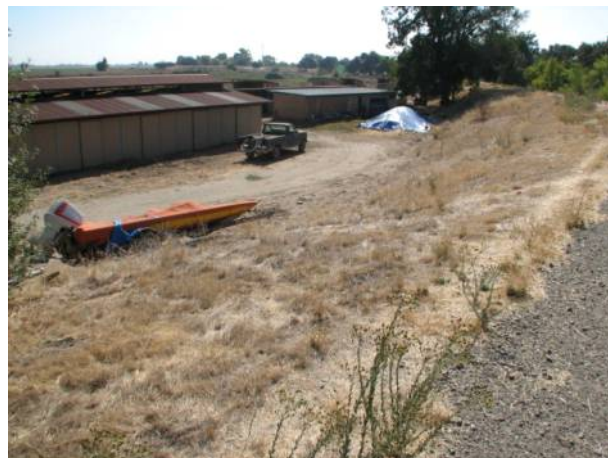
mkhashch\_f\_20120927\_300.jpg

Levee Mile Report Line	29
Start Levee Mile	1.28
End Levee Mile	1.33
Location	Land Side
Category	Earthen Levee
Item	Encroachments

Fall 2009 photo: boat and equipment stored within 10-ft of levee slope are an encroachment.

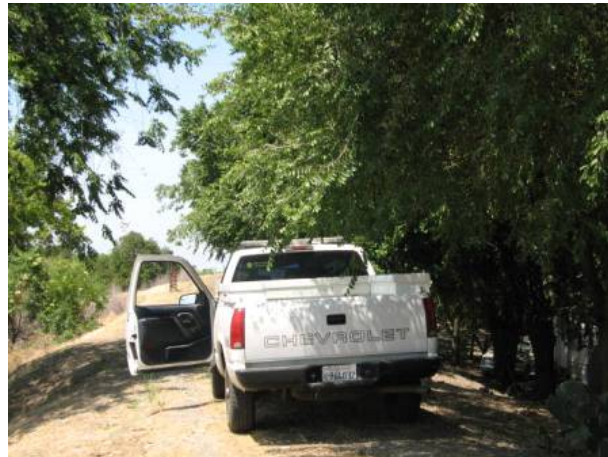
mkhashch\_f\_20120927\_312.jpg

Levee Mile Report Line	30
Start Levee Mile	1.30
End Levee Mile	1.33
Location	Water Side
Category	Earthen Levee
Item	Trim / Thin Trees

05/24/2011 Low hanging trees need to be trimmed up 12' over road.

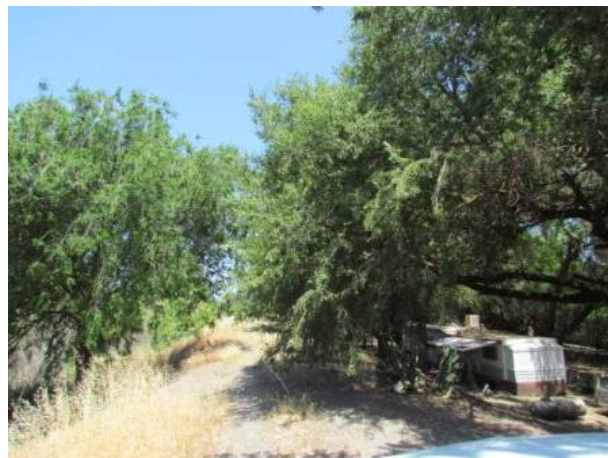
mkhashch\_f\_20120927\_313.jpg

Levee Mile Report Line	30
Start Levee Mile	1.30
End Levee Mile	1.33
Location	Water Side
Category	Earthen Levee
Item	Trim / Thin Trees

View of low hanging branches over levee crown.  
05/24/2012
